OPTIONAL DETERMINATION OF NON-SIGNIFICANCE (DNS) NOTICE MATERIALS

SEPA ENVIRONMENTAL CHECKLIST

KING COUNTY METRO BELLEVUE BASE 1790 124th Ave NE Bellevue, WA 98005

COVER SHEET

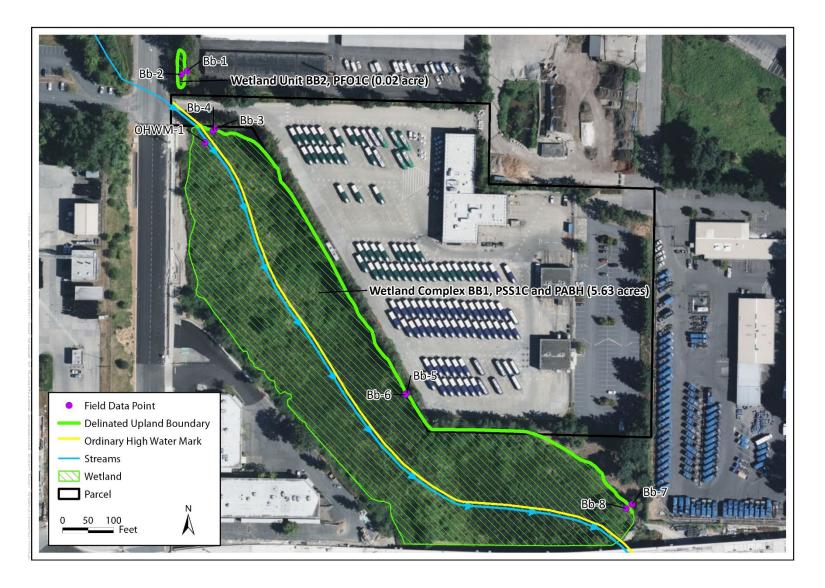
Figure 4
West Tributary OHWM Determination, Wetland Delineation, and Sample Plots

During the site visit, Metro's consultant observed that groundwater was present 8" below ground surface at an elevation of 135 feet above sea level in the northern portion of Wetland BB1 complex at sampling point Bb-4 (Figure 4). Per King County iMAP, the paved curb located in the southwestern portion of the bus yard has the lowest elevation, which is approximately 140 feet above sea level. Therefore, groundwater in Bellevue Base is estimated to be 5 feet below ground surface in some project areas. Since the wireless access points are either mounted on existing light poles or buildings, and the anticipated trenching or directional boring depth will not exceed 3 feet below ground, the chance of encountering groundwater and waste materials entering ground or surface waters is relatively low.

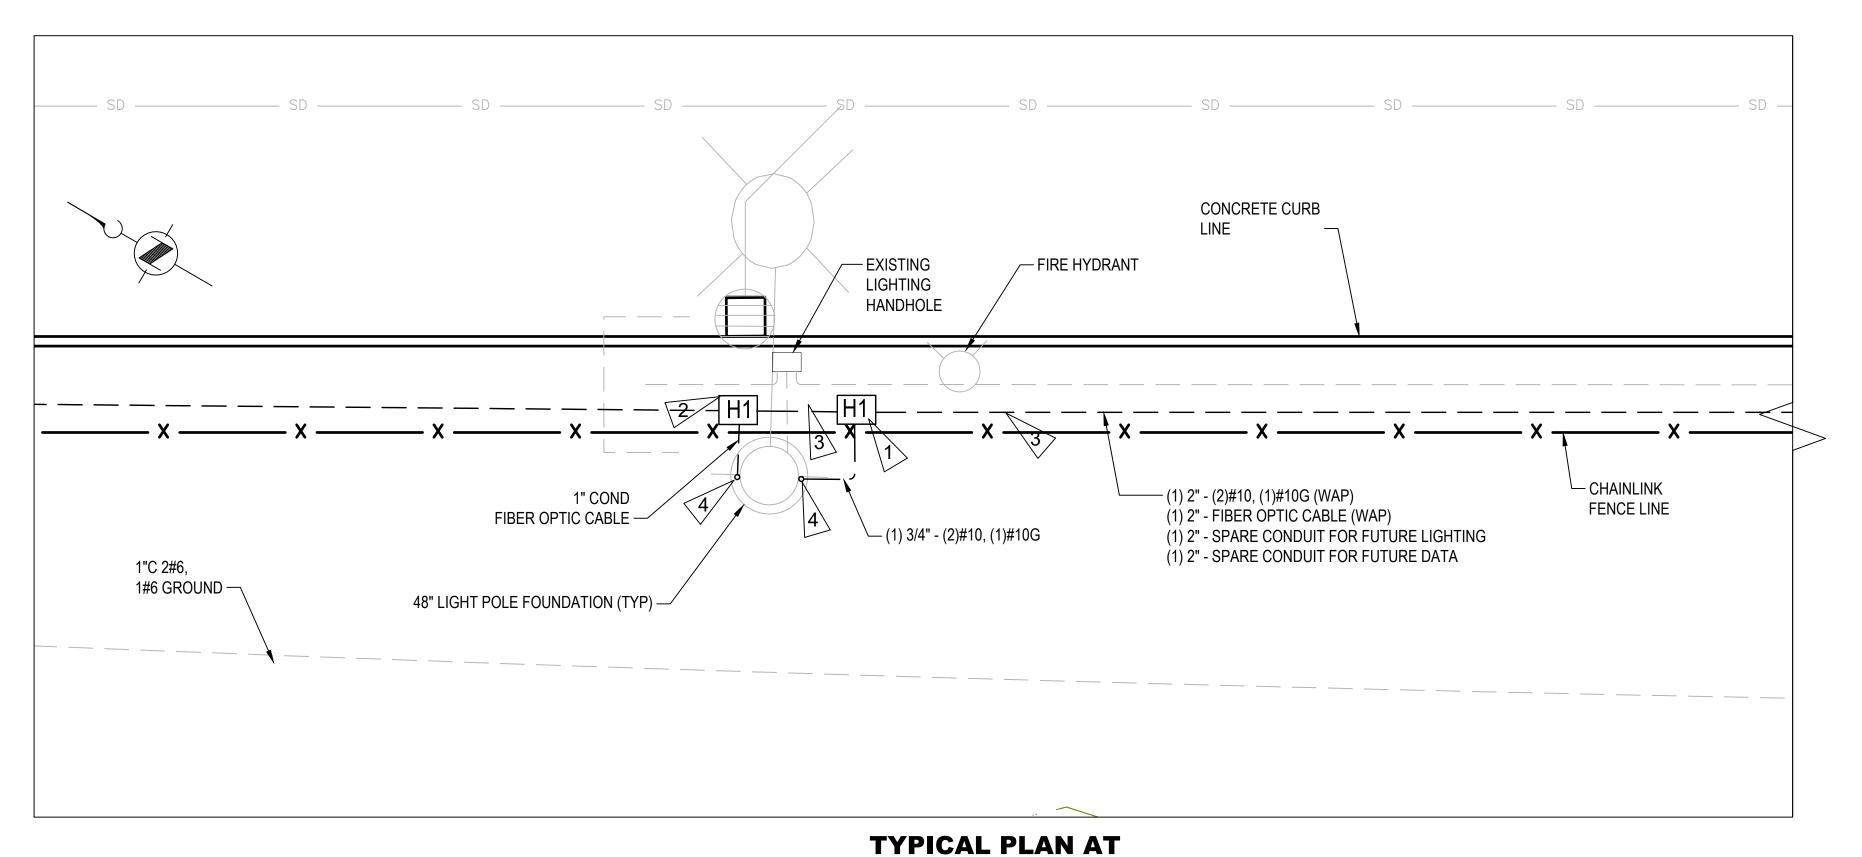
ET2.03

EXISTING LIGHT POLES

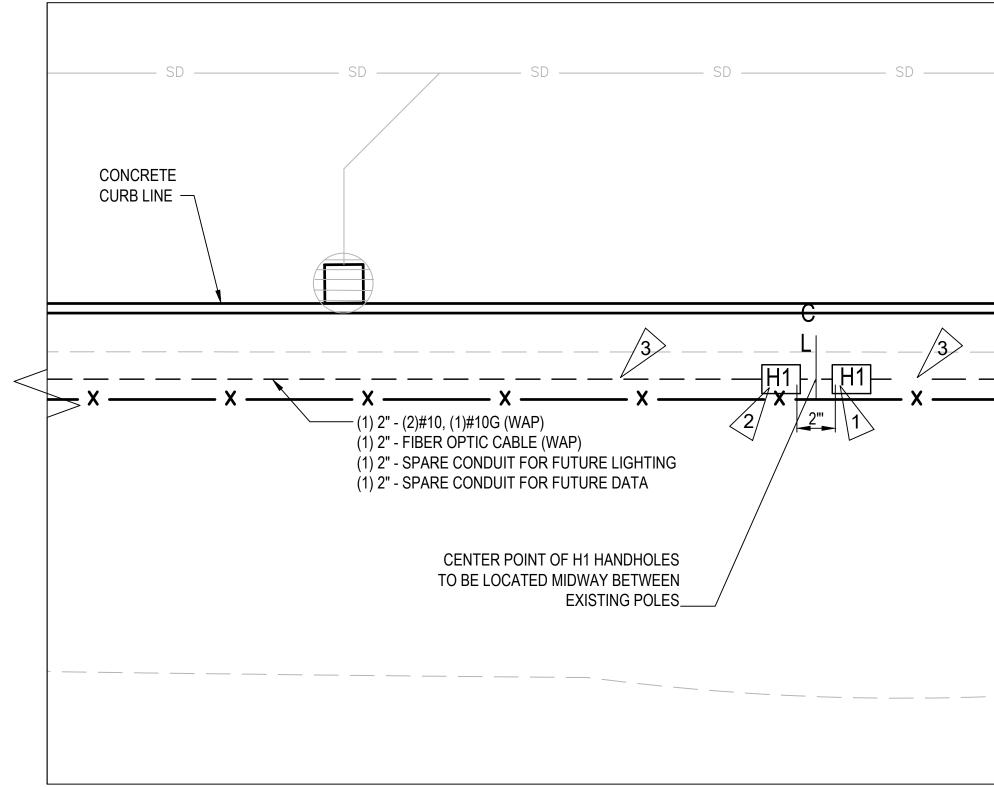
2 PLAN SCALE: 1"=5'-0"

TYPICAL PLAN AT FUTURE LIGHT POLES

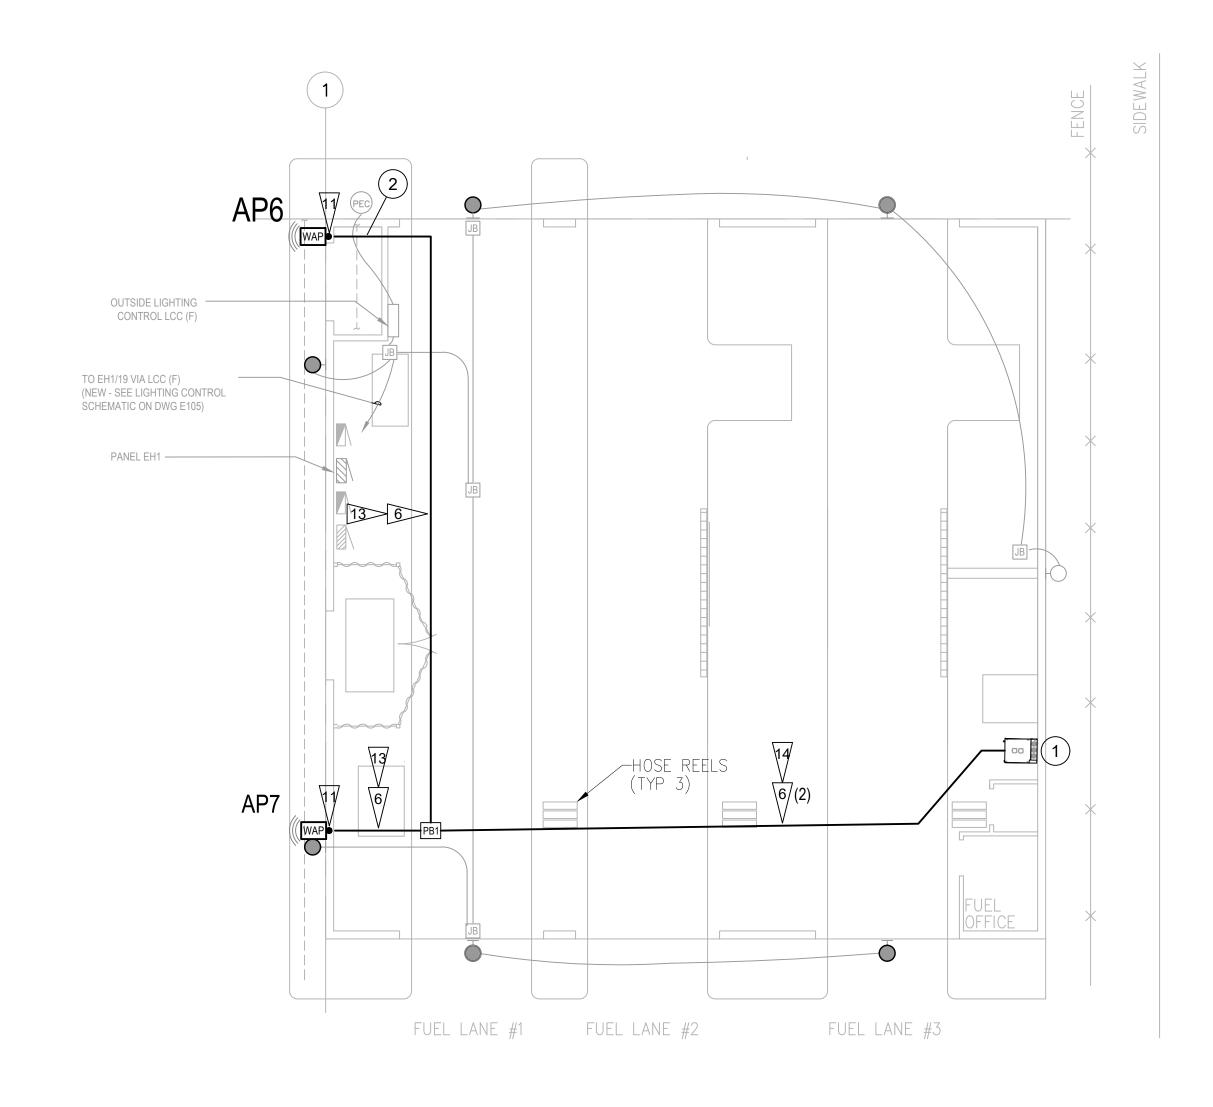
PLAN SCALE: 1/8"=1'-0" ET3.21

FUEL BUILDING

- 1) NEW IDF CABINET. MOVE AND CONVERT EXISTING POWER TO QUAD OUTLET. MOVE FIBER INTO CABINET WITH RACK MOUNT FIBER PANEL
- 2 ROUTE CONDUIT OVER TOP OF HAZARDOUS ROOM AND PENETRATE OUTSIDE. PAINT OUTSIDE CONDUIT.

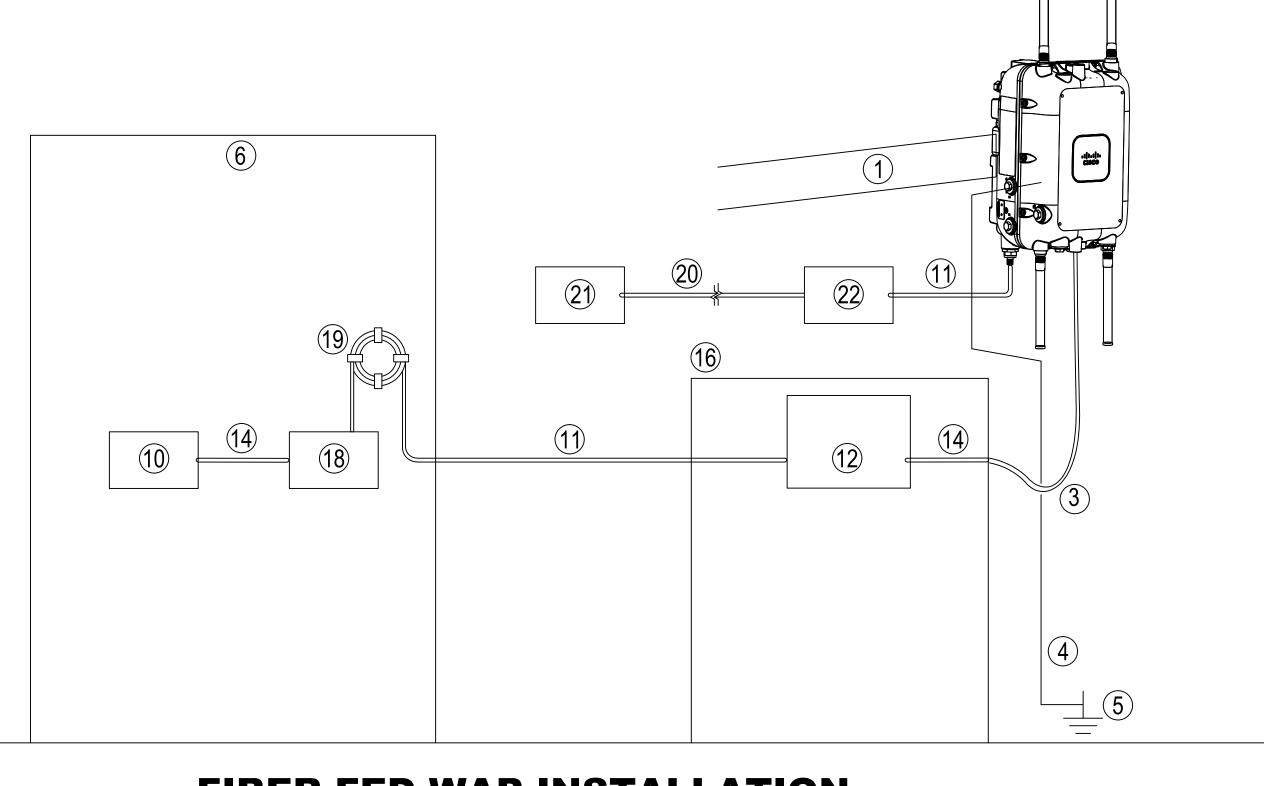
DETAIL 2
SCALE: NTS

FIBER FED WAP INSTALLATION

- ① M8X12MM STAINLESS STEEL BOLTS, USED ⑥ CISCO ANTENNA 11.8"H X 7.9"W X 6.3"D TO FASTEN THE AP TO THE PMK2 WALL MOUNT BRACKET
- POLE
- 3 STAINLESS STEEL BAND STRAPS
- 4 PIVOT BRACKET
- 5 M8X16MM STAINLESS STEEL BOLTS USED TO ATTACH THE STRAP BRACKETS TO THE PIVOT BRACKET. THE STRAP BRACKETS ARE SET FOR POLE OF 6 TO 11 INCHES DIAMETER, AND THE PIVOT BRACKET IS IN VERTICAL ORIENTATION.
- 7 CORNING STAINLESS STEEL ENCLOSURE 12.5"H X 10.5"W X 6.25"D
- 8 1" RGS CONDUIT FROM JUNCTION BOX
- (9) EATON FSS3 BOX WITH DS100G COVER FOR ELECTRICAL WIRES. FS BOX 6 9/32"H X 2 3/4"W X 1 7/8"D
- (10) AIR-ACC-15-AC-PLGS HARD WIRED TO A 12/3 SO CORD
- 11 LC-LC SM OSP FIBER JUMPER
- (12) SO CORD GRIP CONNECTOR

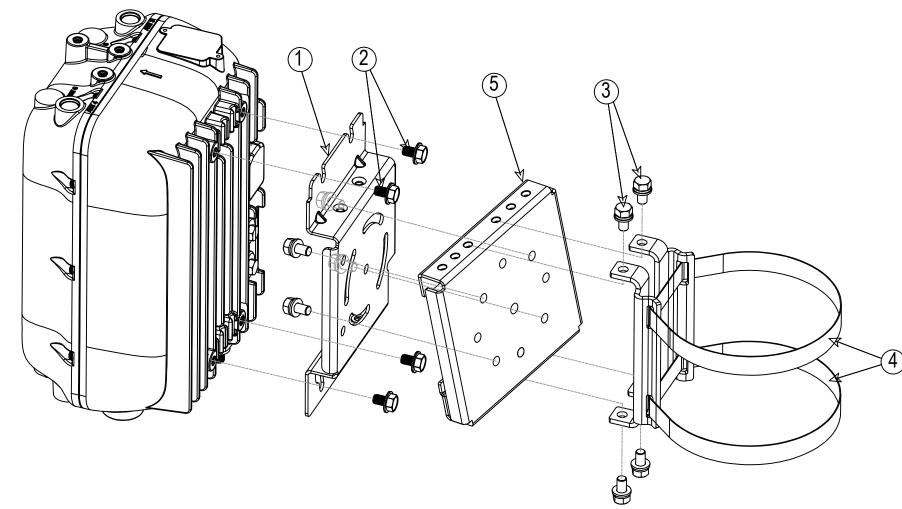
DETAILS	2
SCALE: NTS	ET5.02

- 1) PMK2 WALL MOUNT BRACKET
- 3 M8X16MM BOLTS USED TO ATTACH THE STRAP BRACKETS TO THE WALL MOUNT BRACKET
- **5** PIVOT BRACKET

- (2) M8X12MM STAINLESS STEEL BOLTS, USED TO FASTEN THE AP TO THE PMK2 WALL MOUNT BRACKET
- 4 STAINLESS STEEL BAND STRAPS WILL BE USED. SIZE WILL BE DETERMINED BY EACH POLE THE AP WILL MOUNT TO.

PMK2 MOUNT WITHOUT PIVOT BRACKET FOR WALL MOUNT

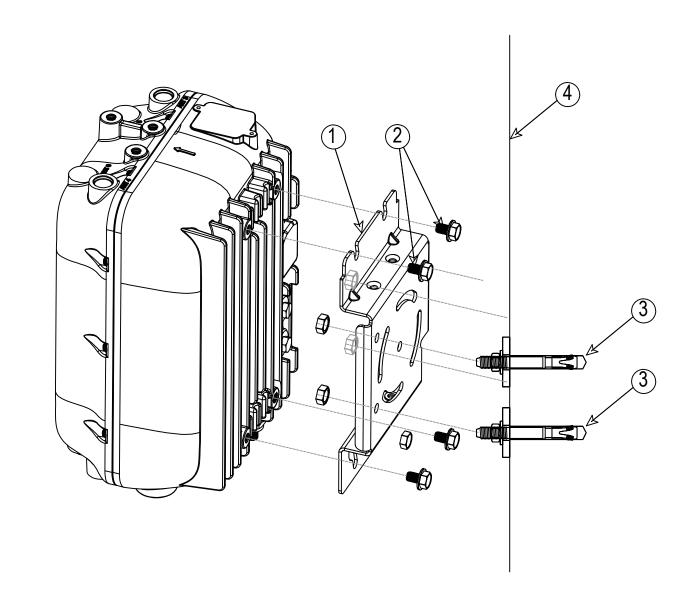
- ① PMK2 WALL MOUNT BRACKET
- ③ INSTALL HILTI SS 304 1/4"X 2-1/4" KWIK BOLT TZ EXPANSION ANCHORS RATED ~600LBS PULL PUT EACH
- ② M8X12MM STAINLESS STEEL BOLTS, USED TO FASTEN THE AP TO THE PMK2 WALL MOUNT BRACKET
- 4 WALL

WALL MOUNTING BRACKET

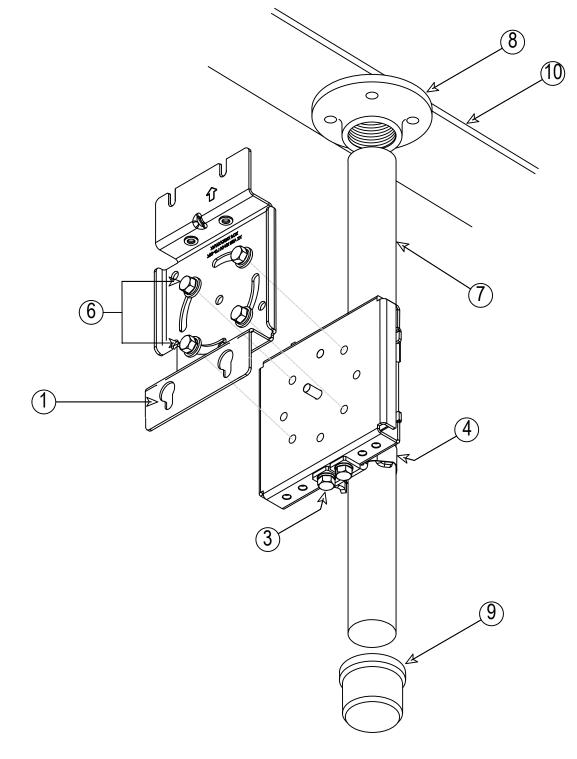
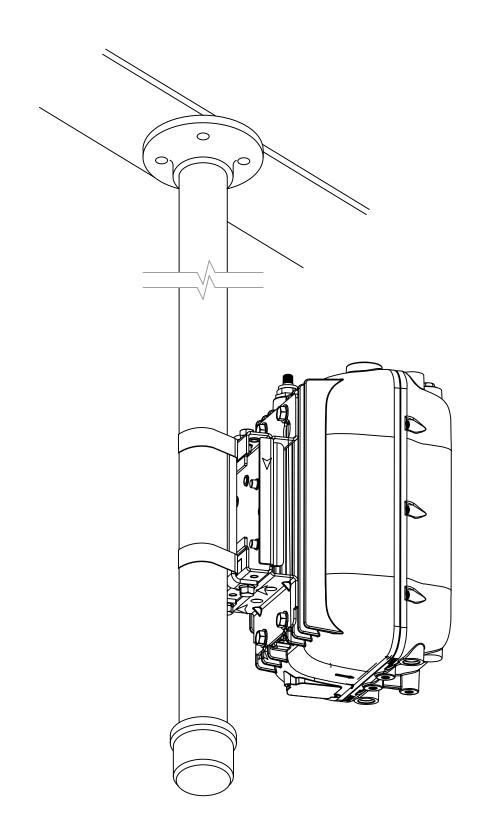
- 1) PMK2 WALL MOUNT BRACKET
- ③ M8X16MM BOLTS USED TO ATTACH THE STRAP BRACKETS TO THE PIVOT BRACKET

5 PIVOT BRACKET
- 7 2" GALVANIZED PIPE LENGTH TO BE DETERMINED IN FIELD AND CAPPED OFF WITH 2" PIPE END CAP
- 9 2" PIPE END CAP

- 2 M8X12MM STAINLESS STEEL BOLTS, USED TO FASTEN THE AP TO THE PMK2 WALL MOUNT BRACKET
- 4 STAINLESS STEEL BAND STRAPS WILL BE USED. SIZE WILL BE DETERMINED BY EACH POLE THE AP WILL MOUNT TO.
- 6 M8X16MM BOLTS USED TO MOUNT THE WALL MOUNT BRACKET ON THE PIVOT BRACKET.
- 8 2" PIPE FLOOR FLANGE, MOUNTED TO THE RED IRON WITH 4 X 3/8" BEAM CLAMPS
- 10 RED IRON BEAM OR UNISTRUT

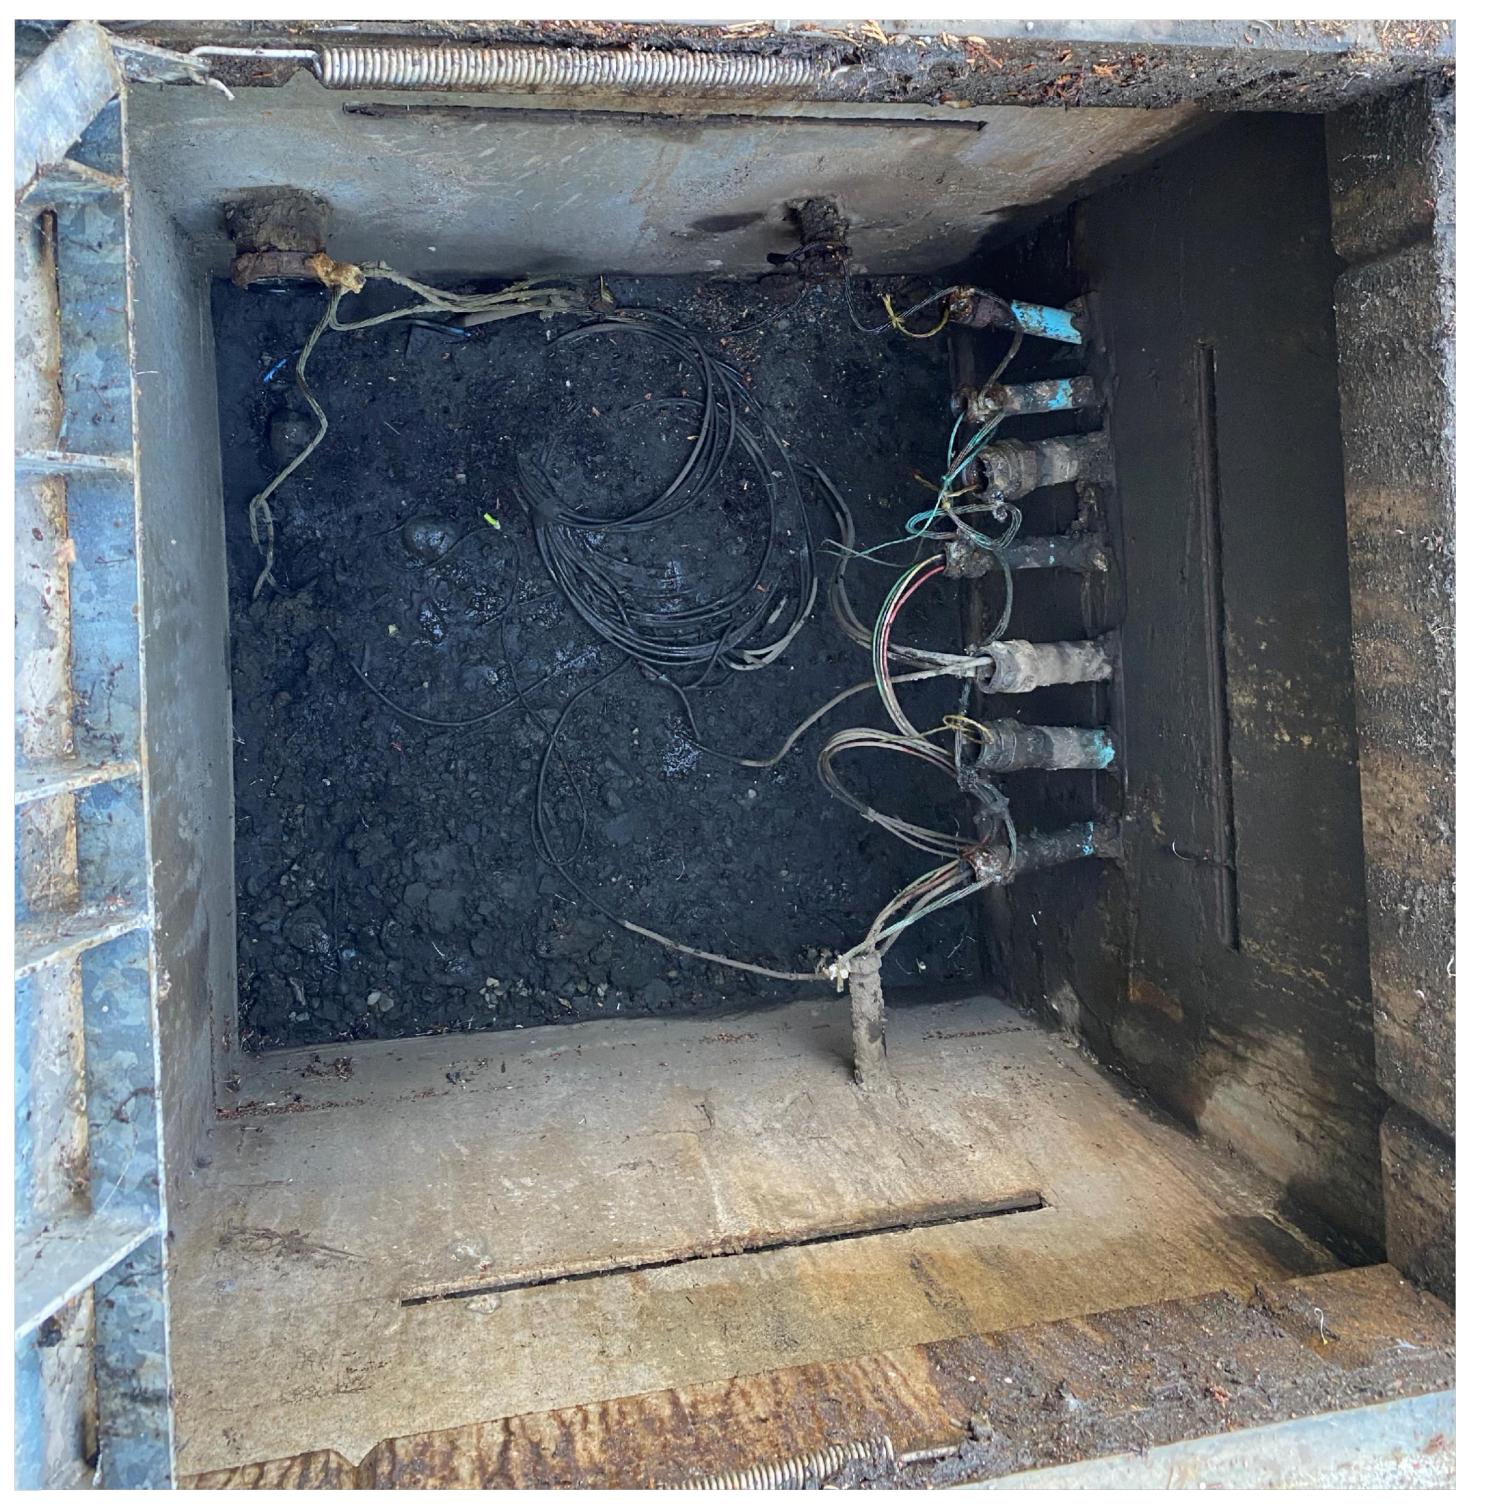
Existing Vault With Conduits From Electrical Room 117

INSTALL AN LB OVER THE 1.5" CONDUIT AND EXTEND A NEW CONDUIT OUT THROUGH THE WALL OF THE VAULT FOR POWER AND COMM.

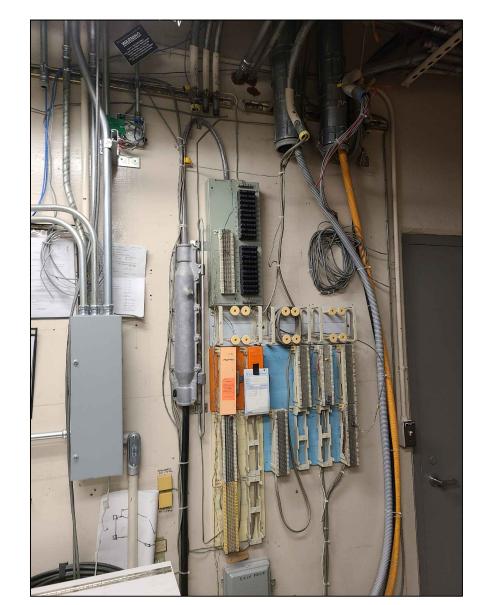
ELEC RM 117 - NORTH WALL 4 ET4.07 ELEVATION
SCALE: NTS

EXTEND POWER WIRING IN CONDUIT — TO PANEL AND FIBER TO MDF VIA J HOOKS PER PLANS AND SCHEDULE

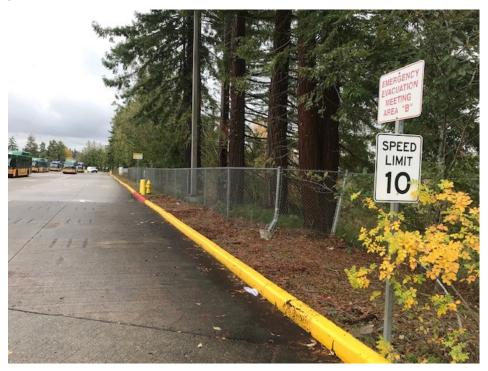
Photo 1 Western Property Boundary – View from North

The property is relatively level across the site with an elevation difference of less than 5 feet. Based on our observation and evaluation, the existing site seems to be raised by several feet of fill along the west portion of the site during original construction. The slope along the wetland

seems to be a fill slope. Photos 1 through 4 show the slope condition along the west property boundary.

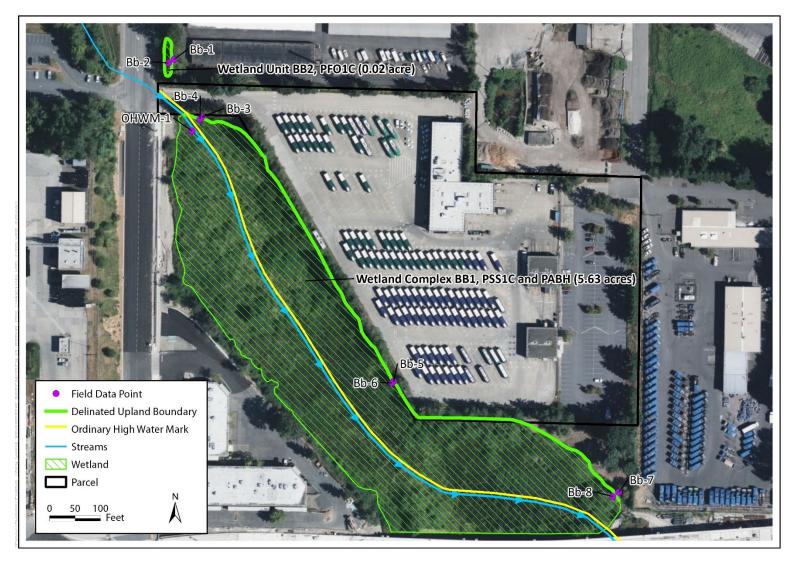
Figure 4. West Tributary OHWM Determination, Wetland Delineation, and Sample Plots

There is one vegetative community in the wetland complex. The vegetative community has an herb layer dominated by reed canary grass (FACW) and broadleaf cattails (*Typha latifolia*, OBL) with willow thickets (*Salix* sp.) scattered throughout. The wetland and aquatic bed pond boundaries were dominated by reed canary grass in the herb layer, Himalayan blackberries in the shrub layer at the toe of slope, and Pacific willow (*Salix lucida* ssp. *Lasiandra*, FACW) and western red cedar (*Thuja plicata*, FAC) in the tree layer.

Herbs observed, but not dominant, in the western emergent wetland included field horsetail (*Equisetum arvense*, FAC), water parsley (*Oenanthe javanica*, OBL), creeping buttercup (*Ranunculus repens*, FAC), and large leaf avens (*Geum macrophyllum*, FAC), with Indian plum (*Oemleria cerasiformis*, FACU), salmonberry (*Rubus spectabilis*, FAC), and Douglas' meadowsweet (*Spiraea douglasii*, FACW) observed in the shrub layer. Red osier dogwood (*Cornus alba*, FACW) and nootka rose (*Rosa nutkana*, FAC) were noted near the aquatic bed pond boundary with slough sedge (*Carex obnupta*, OBL) and common monkeyflower (*Mimulus guttas* spp. *Guttas*, OBL) in the aquatic bed. Redwood and big leaf maple were noted in the tree layer in the study area.

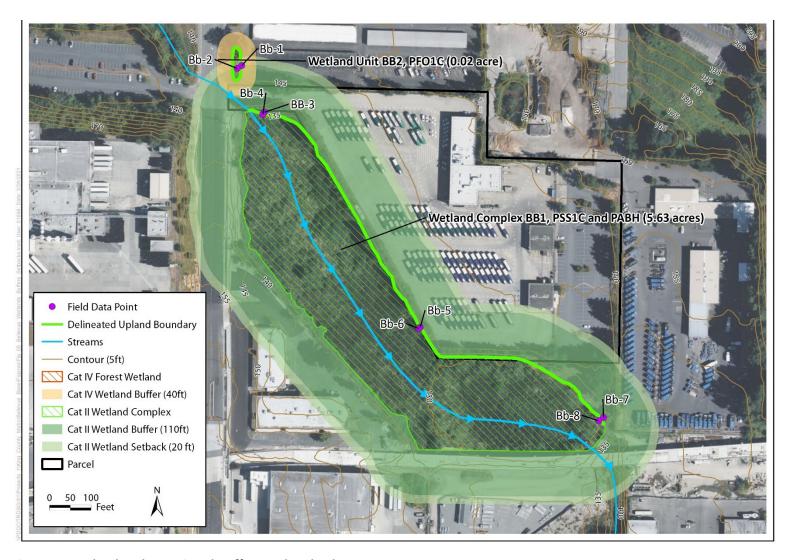
Figure 5. Wetland and Associated Buffers and Setbacks

Based on City of Bellevue Ordinance Codes discussed in Chapter 2, *Regulatory Framework*, all new construction on developed or undeveloped areas along the West Tributary in the Kelsey Creek basin is required to have a 50-foot buffer from the top of bank, with an additional 20-foot structural setback from the buffer (Figure 6). As part of the permitting process, any development within these areas must mitigate for possible impacts from the project. This buffer lays entirely within the Bellevue Base bus parking area and provides minimal wildlife habitat or hydrological improvements to the West Tributary to Kelsey Creek.
